Sanitary Survey Report

**Polacca, Arizona
PWSID #0400106**

Survey Conducted on April 7, 2014

**Sanitary Survey
Polacca
PWSID #0400106
Survey Performed April 7, 2014**

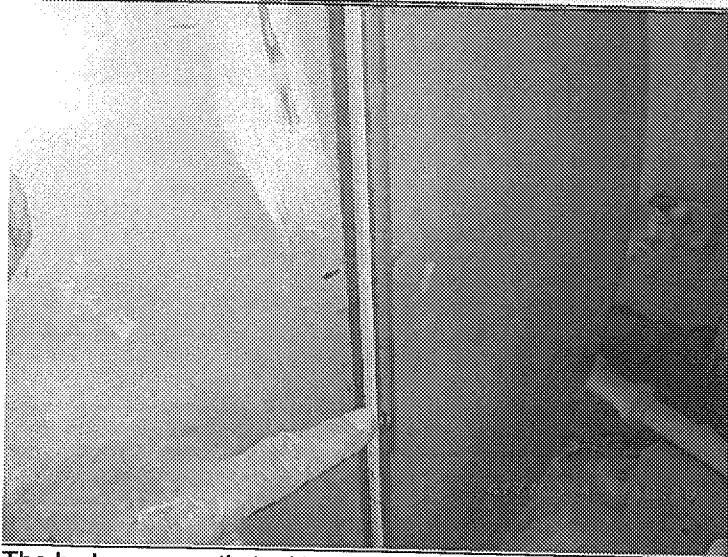
Comments: 2 booster pumps. Based on run time and reported pump capacity, only 120 gallons of the tank's capacity is being used. Observation of the sight gauge confirms this and it seems inefficient. Also, pumps of this size generally should run more than 2 minutes when they come on (this is a rule of thumb – not necessarily something that is true in all cases).

The hydropneumatic tank's (HP001) sight gauge.

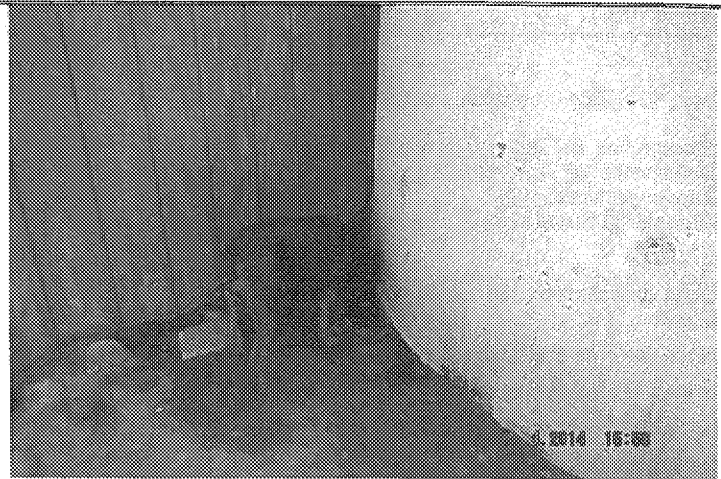
Comments: The mesa tank has not been cleaned for a long time. It is in poor condition and is leaking at its base. A cursory investigation would lead one to believe that replacement of the tank is in order. Pumping to the tank from the distribution system is manually controlled and leads to overflowing water regularly and running out of water occasionally. The latter problem subjects the upper mesa distribution system to pressure loss and risk of contamination. The tank is to be replaced in 2014.

Leak and corrosion of tank.

The two photos above are nearly identical to the two included in the 2010 sanitary survey report. No attempt has been made to correct these deficiencies. Clearly, the tank needs to be replaced; however, with just a little effort, improvements could be made to correct these kinds of sanitary deficiencies. Simple addition of silicone caulking would keep insects and dust from entering the tank through the openings shown in the lower photo.

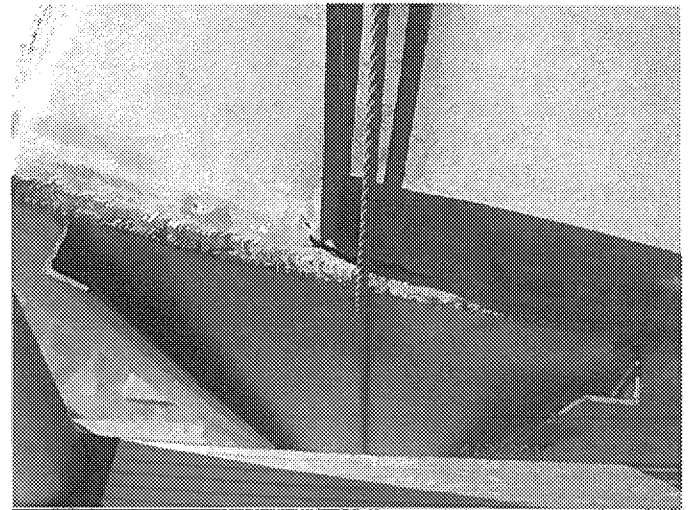
The roof of the tank is corroded and there are openings to allow contamination to enter the stored drinking water.

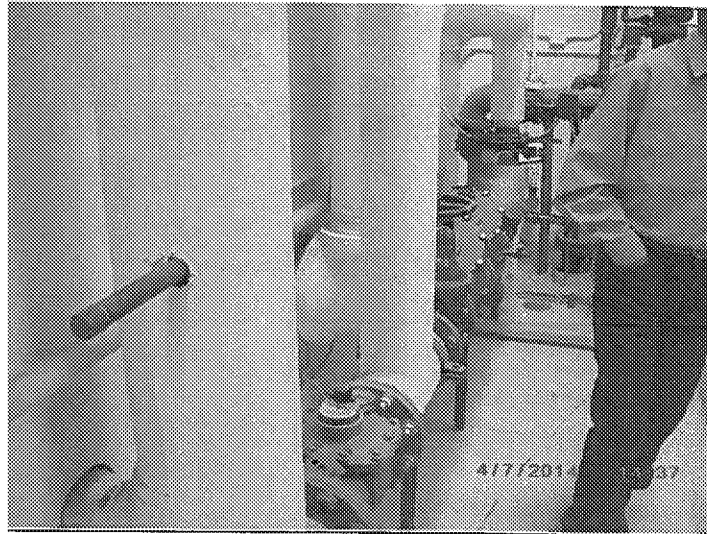
Some service lines are protected with backflow prevention assemblies. However, the ones looked at during the survey (at the health facility) have not been tested as required and the main service line has an unprotected bypass on the service line's backflow preventer. There are likely other facilities served by the PWS that have, or should have, backflow preventers that should be tested annually. The PWS needs to make sure the testing is done and, when necessary, repairs or replacements made.

The backflow preventer on the IHS health center is only a double gate, double check and it has an unprotected bypass.

The system needs to identify and locate all backflow preventers and see that they are tested on an annual basis by a certified tester.

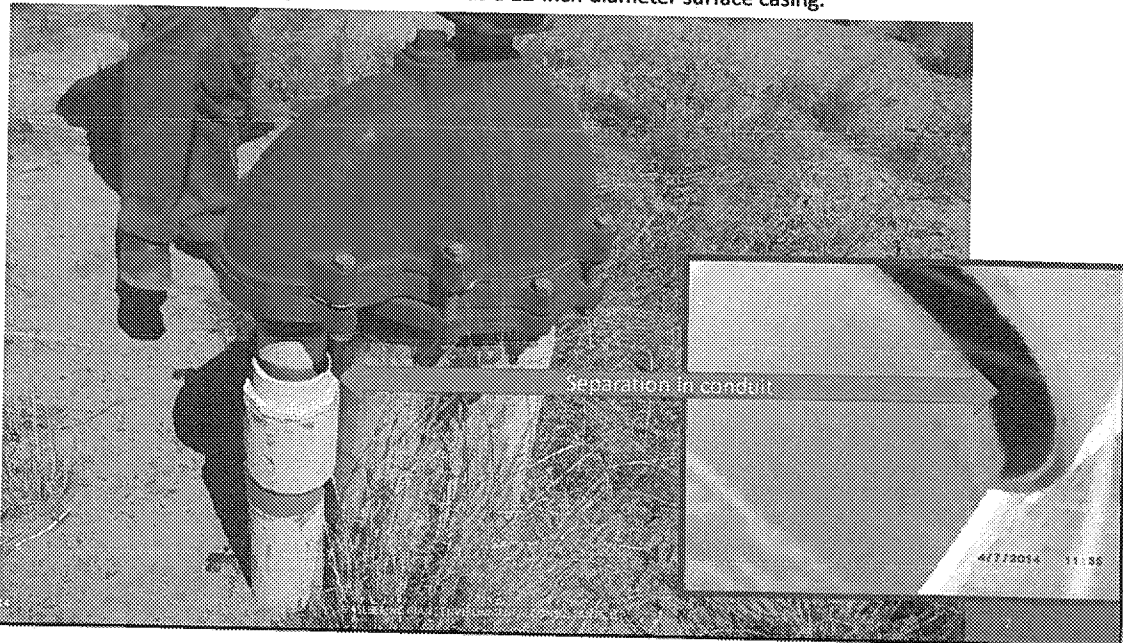
GW002/West Well 6 – Photo 2: GW002 is located 75 yards northeast of the treatment plant (TP001). The well is the only active well on the west side of the PWS. The casing extends more than 18 inches above grade and has a sanitary seal. The sanitary seal is vented, gasketed but one bolt is missing and needs to be replaced. The electrical conduit has separated creating an opening that would allow insects and dust to enter the casing and contaminate the water. The well is not protected by a security fence and its sanitary seal has no locking device. IHS records show it was drilled to a depth of 915 feet but detailed construction records, including grouting, were not available for the surveyors.

GW002/West Well 6: This well is the only one in service on the west side of the PWS. It produces about 130 gpm. The sanitary seal is vented and screened but the conduit is separated. The opening offers opportunities for insects, spiders and dust to enter the casing. The well does not have a security fence. The well has a 12-inch diameter surface casing.

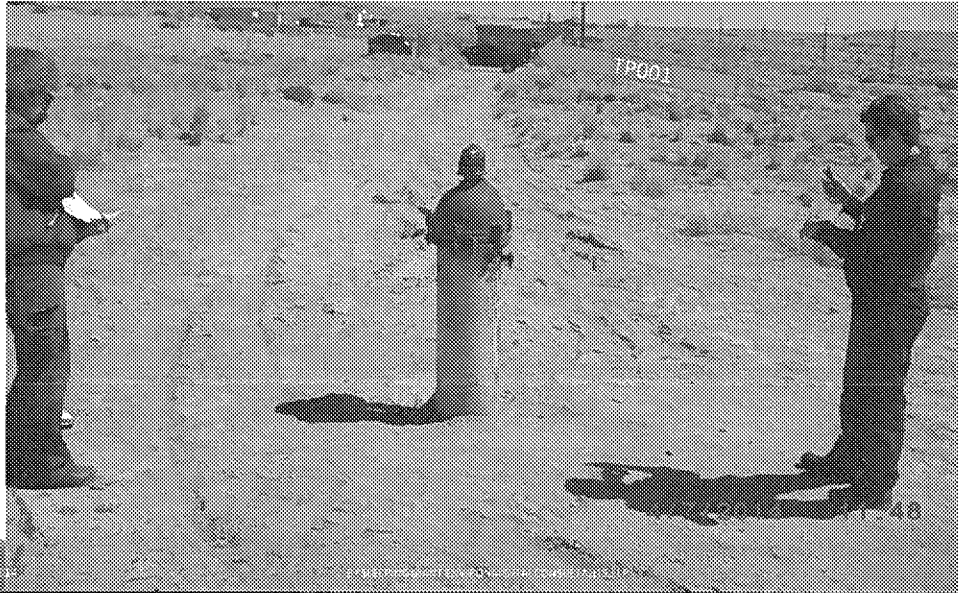
GW003/West Well 5 – Photo 3: GW003 is located 85 yards southwest of the treatment plant (TP001). This well has been inactive since 2006. It reportedly produces water of better quality than that of GW002. Both wells appear to be completed in the same aquifer so it seems unlikely that the quality would differ a lot. The casing extends about 3 ½ feet above grade and has a sanitary seal. The sanitary seal appears to be missing its gaskets and there is a low area around the casing where water can pool and migrate down the casing. The well is designed to pump to TP001 where its water will combine with that of Well 6 and disinfection will occur. Information provided by the IHS indicates that the well has a 40-hp 150-gpm Grundfos submersible pump that was installed in 2012. Unfortunately, the well still is not functional and there seems to be some disagreement about what exactly the problem is.

GW003/West Well 5: This well also has a 12-inch diameter surface casing. It has been offline for years. It reportedly has a new pump but doesn't produce water. There appears to be disagreement about the cause of the problem and apparently not a lot of interest in figuring it out and making corrections. The area around the casing is poorly graded offering an opportunity for water to pool and migrate down the casing

Recommendation: Well 5 should be repaired and put back in service.

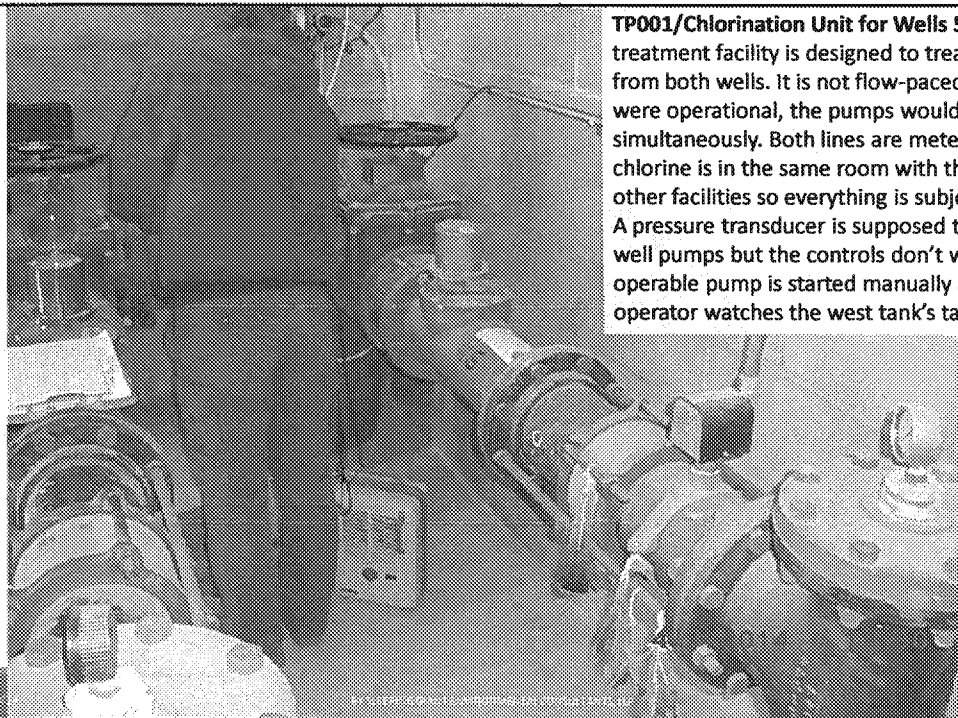
TP001/Chlorination Unit for Wells 5 and 6: This treatment facility is designed to treat the water from both wells. It is not flow-paced so if both wells were operational, the pumps would have to run simultaneously. Both lines are metered. The chlorine is in the same room with the controls and other facilities so everything is subject to corrosion. A pressure transducer is supposed to control the well pumps but the controls don't work so the operable pump is started manually and the operator watches the west tank's target.

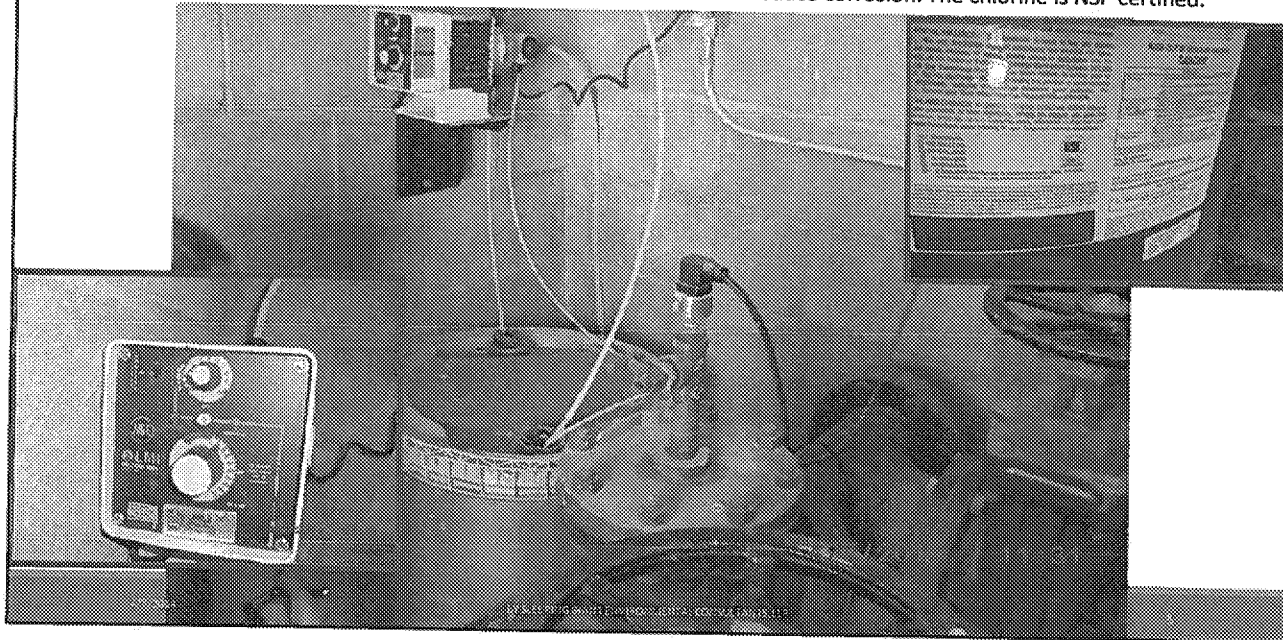
The treatment plant consists of an LMI positive displacement injection pump and a chlorine solution tank. The injection pump is sized to chlorinate the flows from both wells simultaneously; however, with GW003 out of service, the pump's speed is set at 20 percent and its stroke at 20 percent. These low settings are likely to be less accurate than higher settings would be. Also, the low frequency rate causes delayed and poor mixing of the chlorine.

All of the facilities are located in the same room and, thus, are subject to the corrosive effects of chlorine. The vat of sodium hypochlorite solution is not sealed with a vent to the outside of the building to reduce the corrosion.

TP001/Chlorination Unit for Wells 5 and 6: The LMI metering pump is set at 20% stroke and 20% speed. This would lead one to believe it is oversized or the chlorine solution should be diluted. The pumps should run in their midrange to function best (per Milton Roy). The vat of chlorine is not sealed and vented to the exterior to reduce corrosion. The chlorine is NSF-certified.

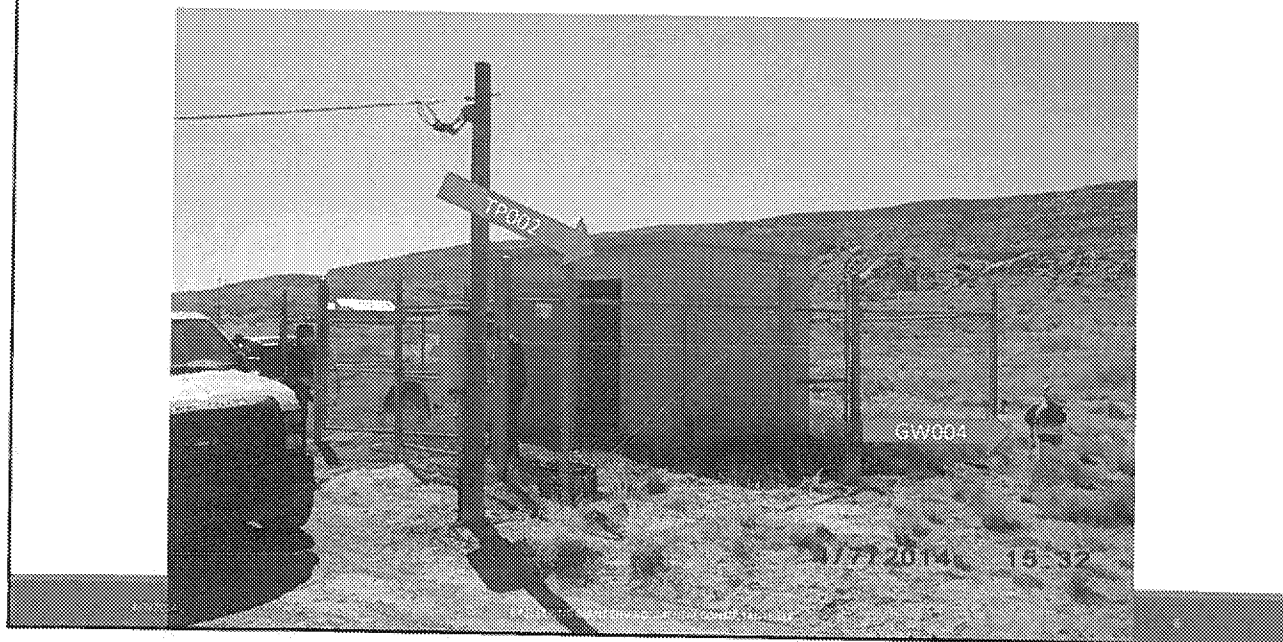
GW004/East Well 8 – Photos 6-9: GW004 is located at the northeast part of the PWS. It is located a few yards outside the secured enclosure for its treatment plant (TP002). Its casing extends more than 18 inches above grade and is fitted with a properly vented sanitary seal. One of the sanitary seal's bolts is missing its nut which should be replaced. The well is not protected by a security fence and its sanitary seal does not have a locking device.

GW004/East Well 8 & TP002/Chlorination for Well 8: This well was producing 92 gpm at the time of the survey. It too is operated manually. The automation doesn't work and the timer doesn't work. The well does not have the protection of a security fence.

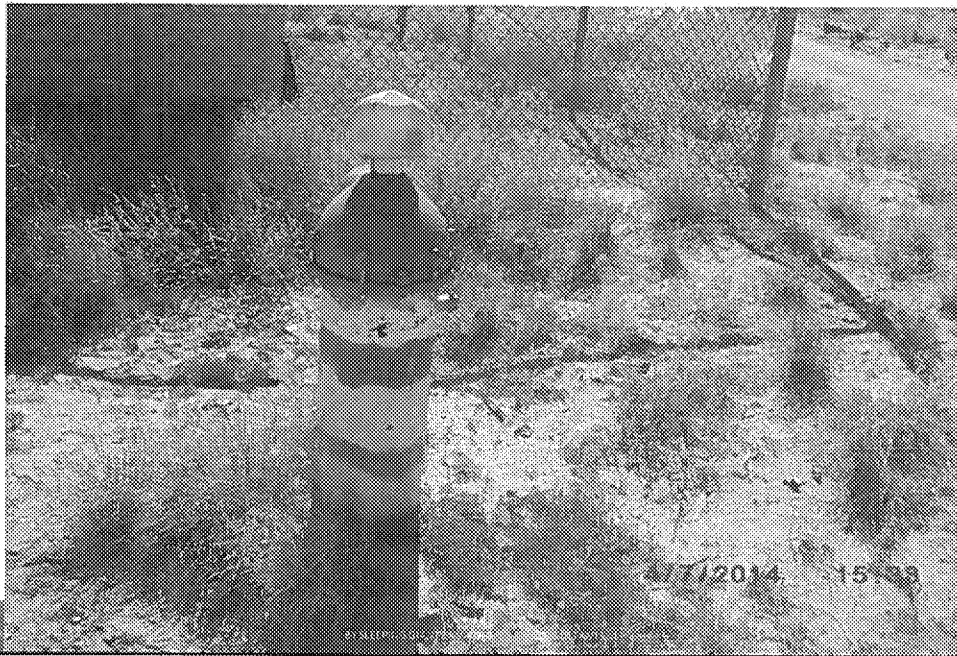
GW004/East Well 8: The casing has a vented sanitary seal. The water enters the first room of the building where it is metered. It flows to the second room where chlorine is injected for disinfection.

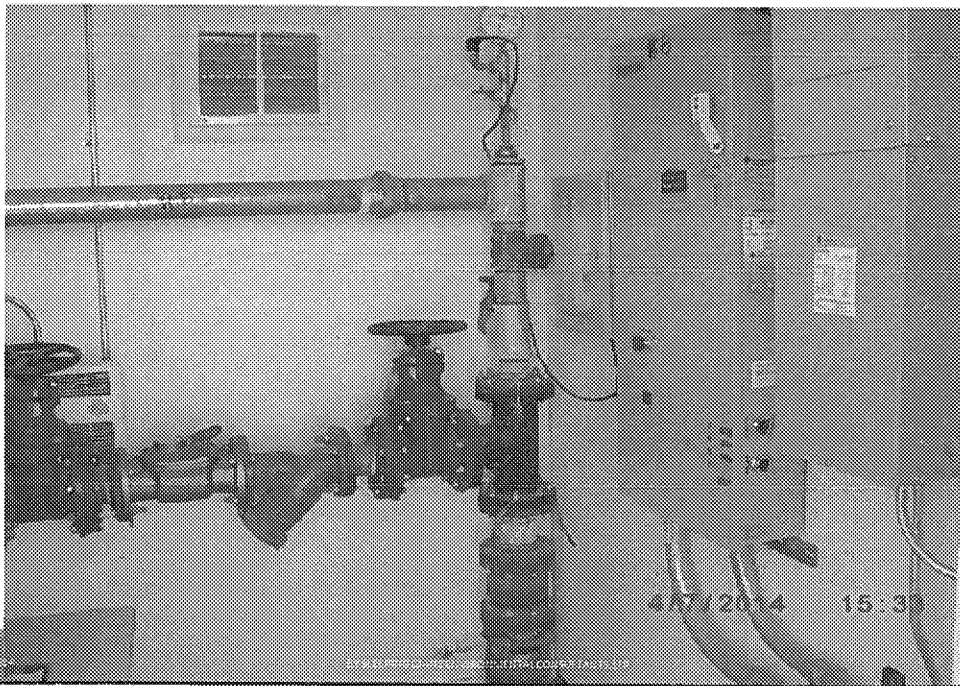
Metering of Well 8: Metering occurs here, the pressure transducer and timer are not functional.

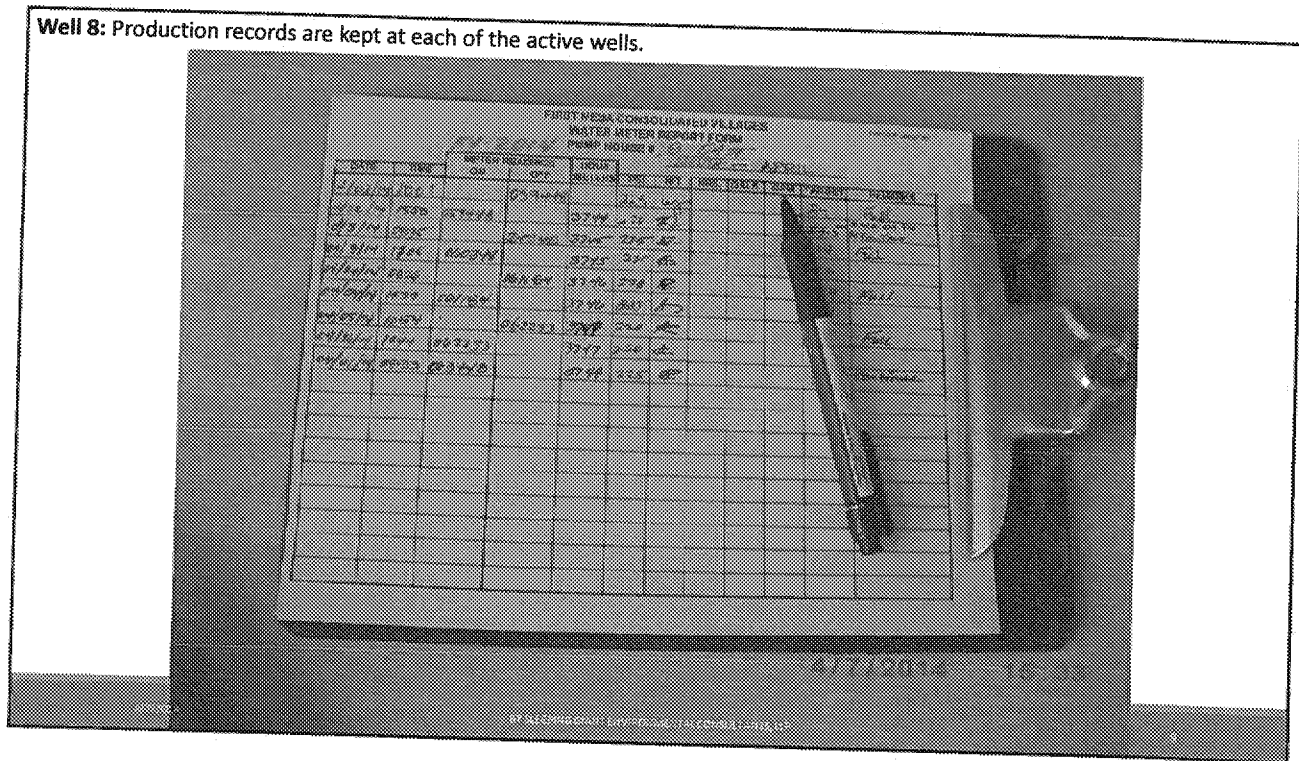
Well 8: Production records are kept at each of the active wells.

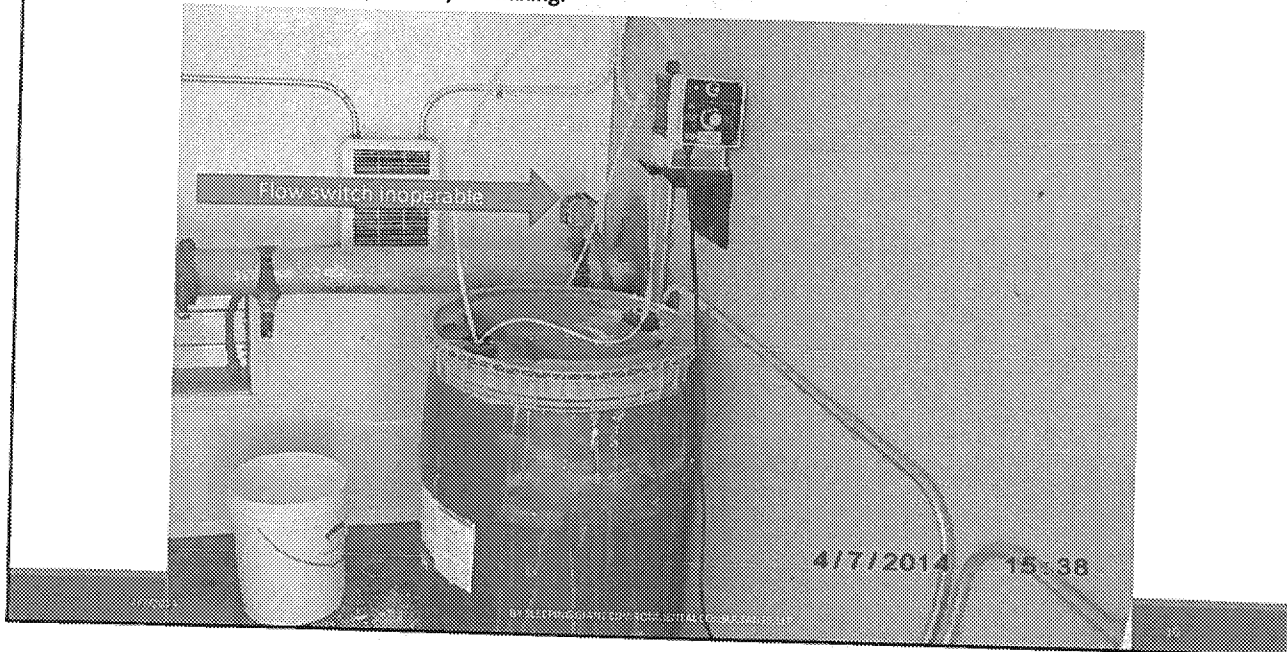
TP002/Treatment Plant for Well 8 (TP002) – Photos 6 & 10-11: TP002 provides disinfection for Well 8 (GW004) with 12.5 percent NSF-approved sodium hypochlorite solution (Photo 10). The treatment plant consists of an LMI positive displacement injection pump and a chlorine solution tank. The pump's speed is set at 20 percent and its stroke at 12 percent. This causes problems like those discussed earlier regarding TP001. In this case, however, the water is reportedly pumped directly to ST002 where mixing will occur and contact time is provided. If there are services connected to the transmission main, the pump should be changed out for one with a smaller capacity. Alternatively, the 12.5 percent sodium hypochlorite solution could be diluted to a level that would allow the metering pump to be operated in its mid ranges.

Chlorination for Well 8: The chlorine is injected with an LMI pump with the speed at 20% and the stroke at 12%. Again, the pump is over-sized unless the chlorine solution is diluted. As it was operating during the survey, a slug of chlorine was injected into the line every few seconds with no opportunity for mixing.

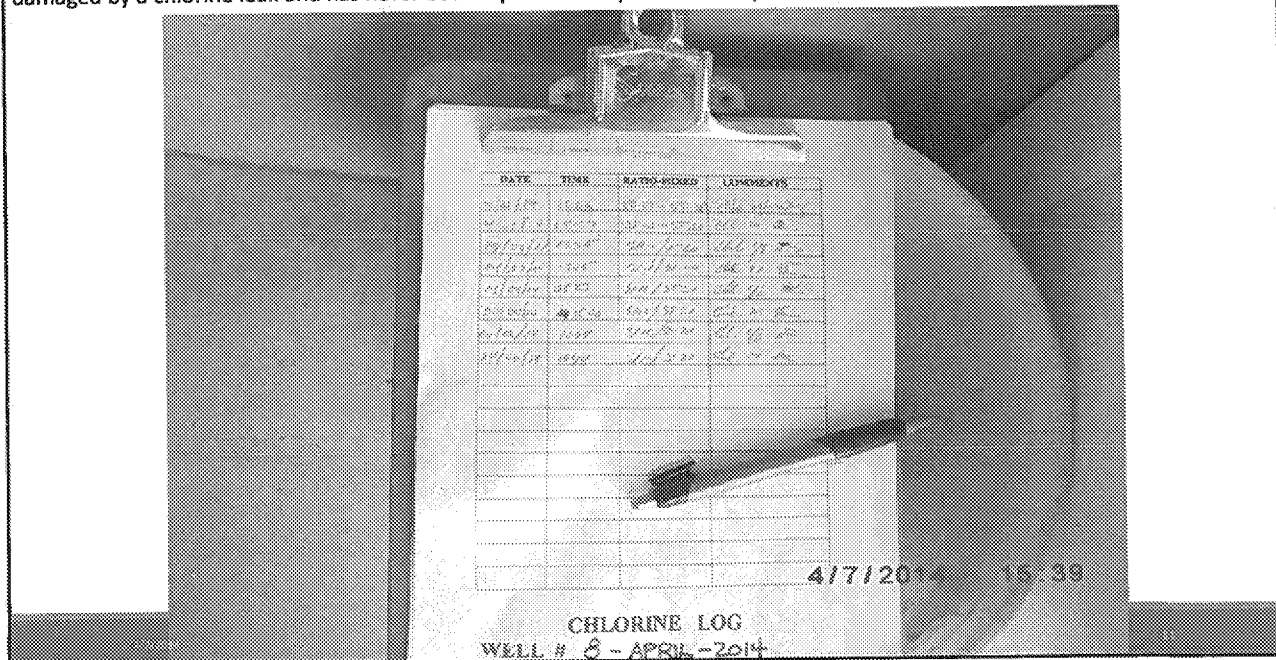
GW004/East Well 8 & TP002/Chlorination for Well 8: The chlorinator also has to be turned on manually. The flow switch was damaged by a chlorine leak and has never been replaced. The photo is the operator's records regarding the disinfection system.

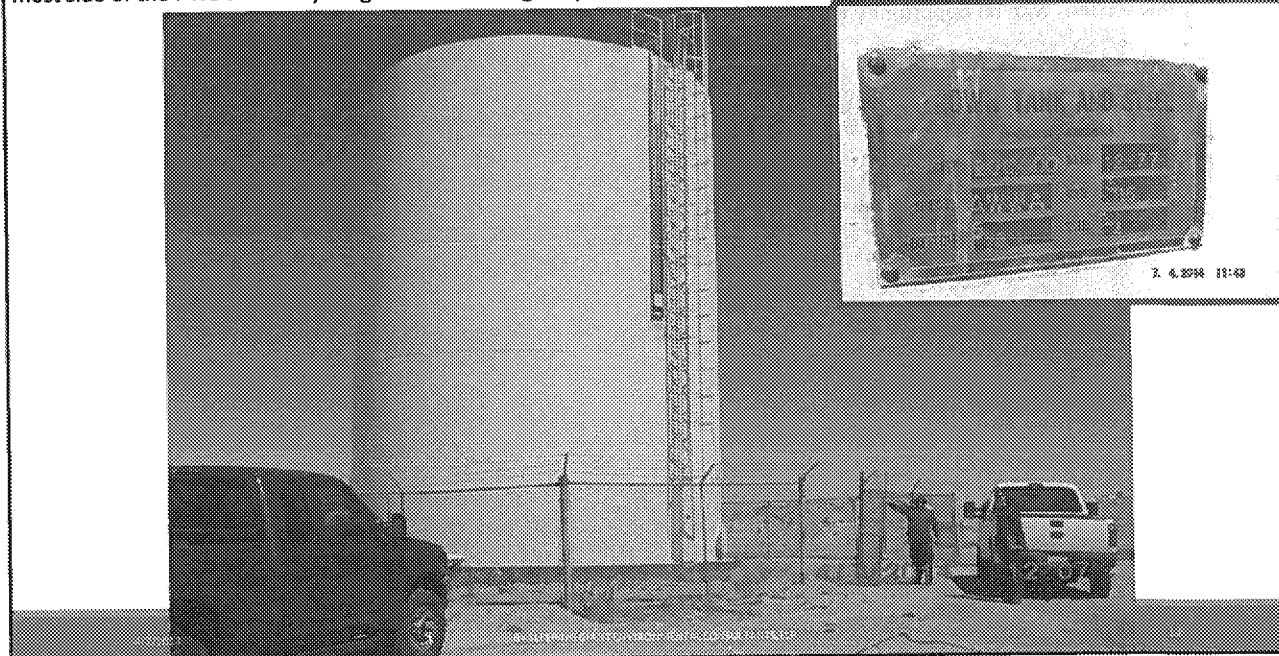
ST001/Older West Storage Tank: This is a 200,000-gallon welded steel storage tank. It almost exclusively serves the western-most side of the PWS and everything south of the highway. The tank shows obvious signs of long term neglect.

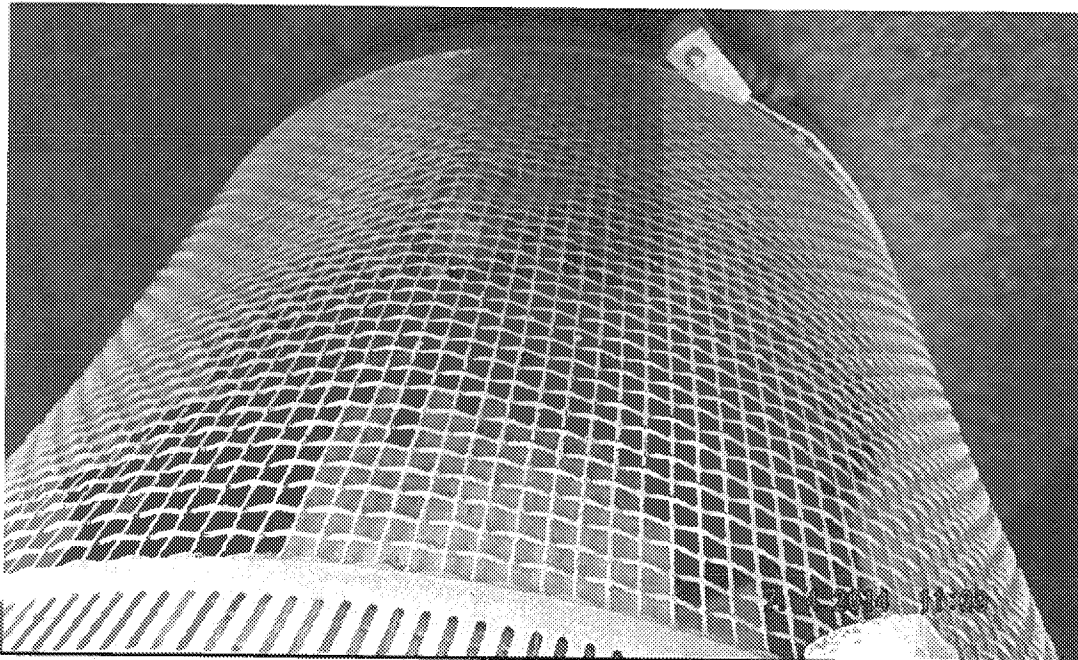
ST001/Older West Storage Tank: The vent is screened but the mesh is too large to exclude insects. This screen should be covered with a non-corrodible insect screen.

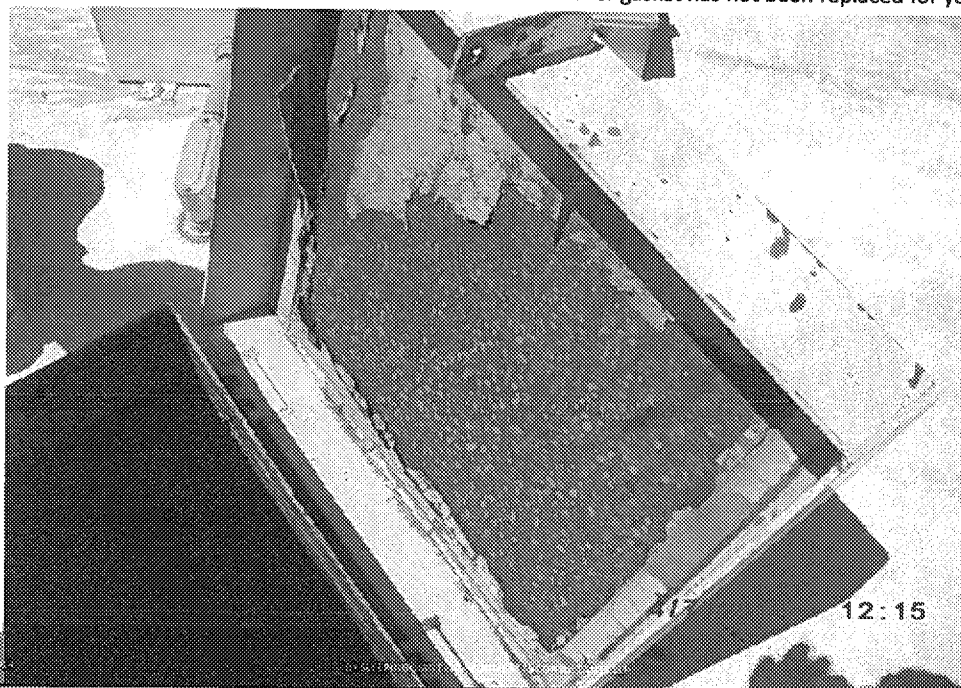
ST001/Older West Storage Tank: Note the corrosion and that the hatch cover gasket has not been replaced for years.

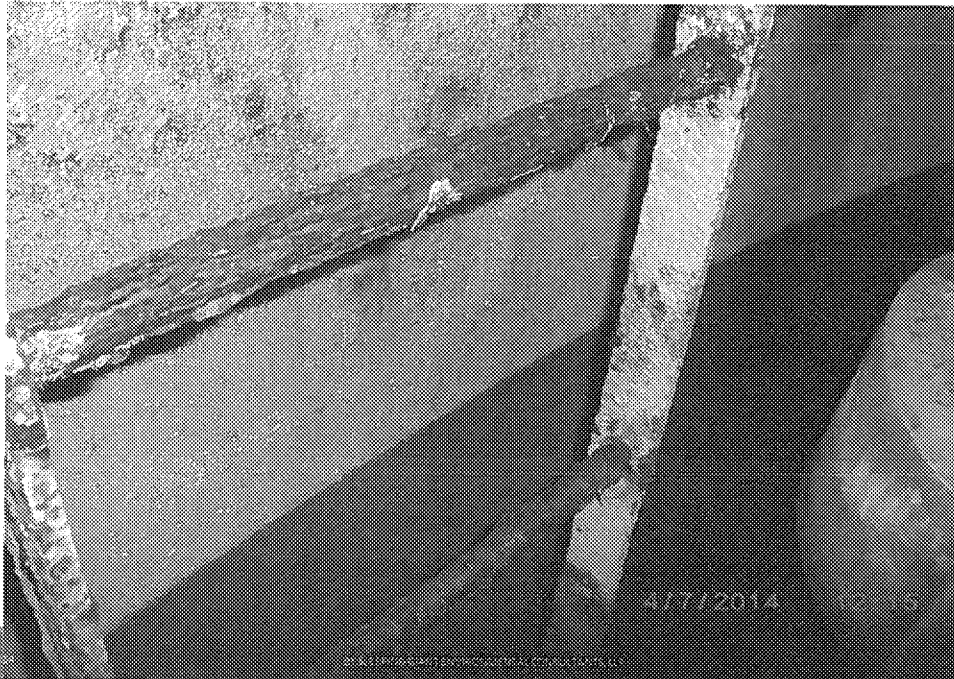
ST001/Older West Storage Tank: Additional signs of long term neglect.

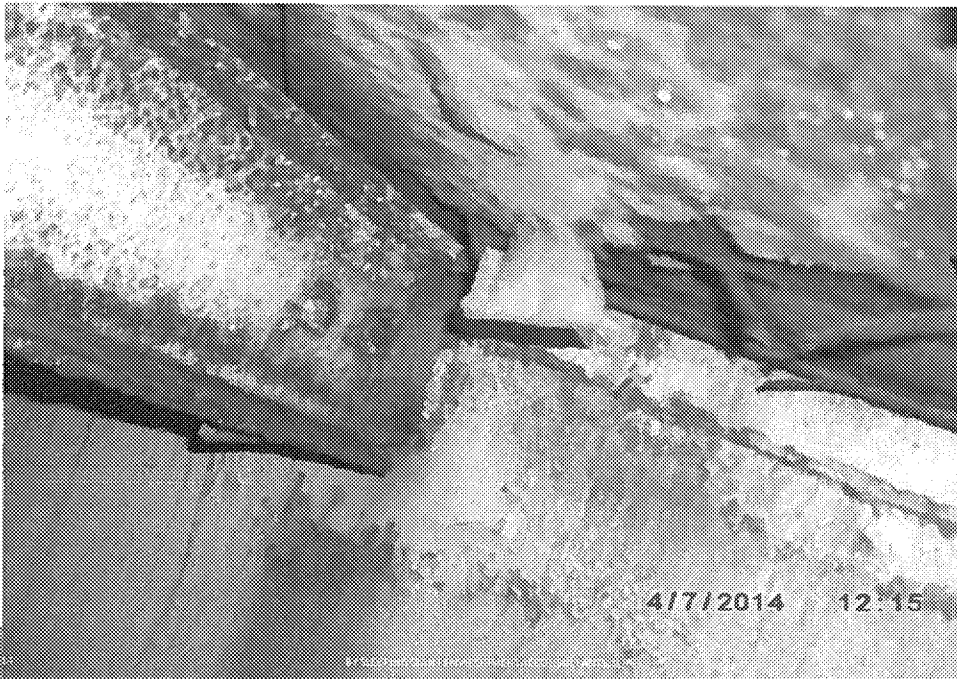
ST001/Older West Storage Tank: The tank needs immediate attention. It should be taken offline and rehabilitated.

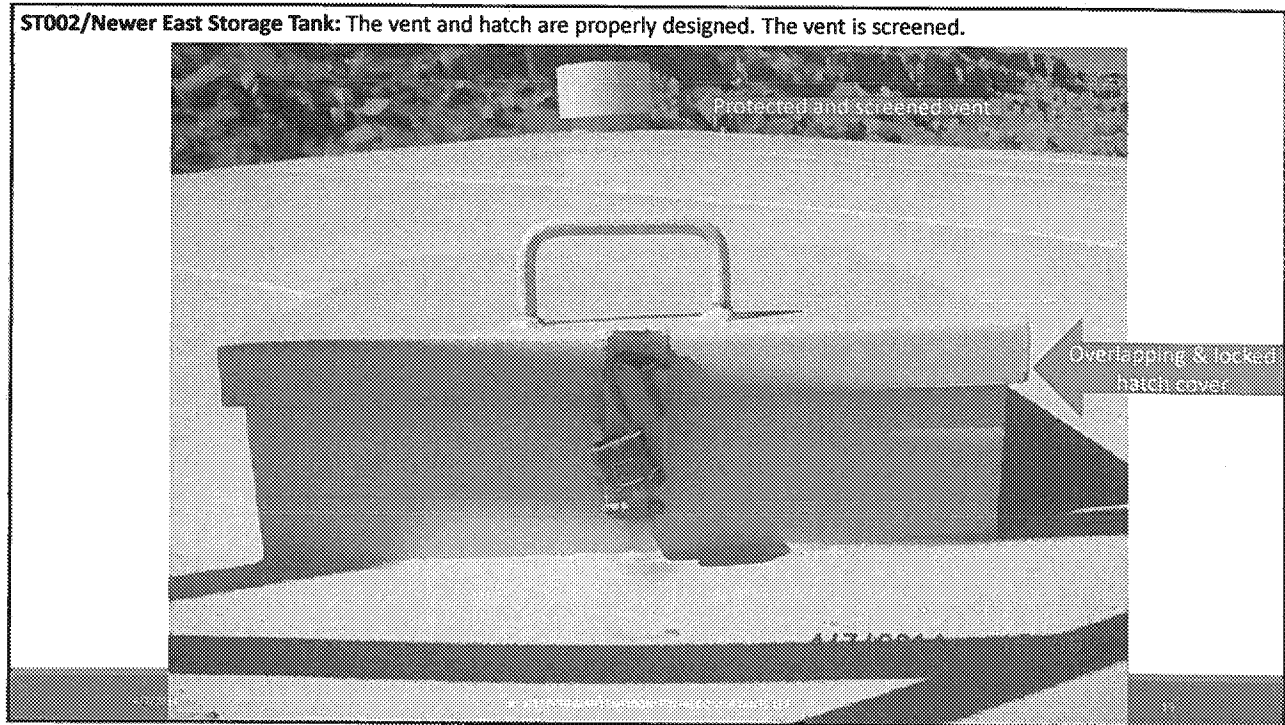
ST002/Newer East Storage Tank: The vent and hatch are properly designed. The vent is screened.

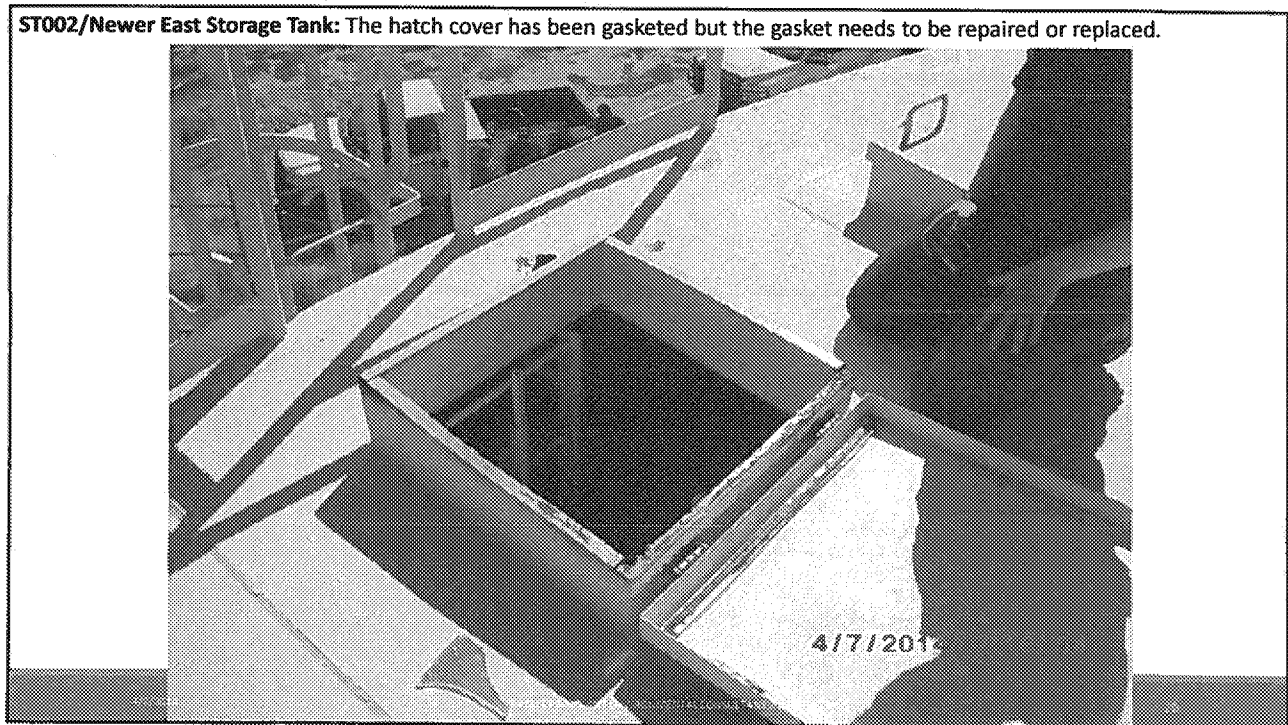
ST002/Newer East Storage Tank: The hatch cover has been gasketed but the gasket needs to be repaired or replaced.

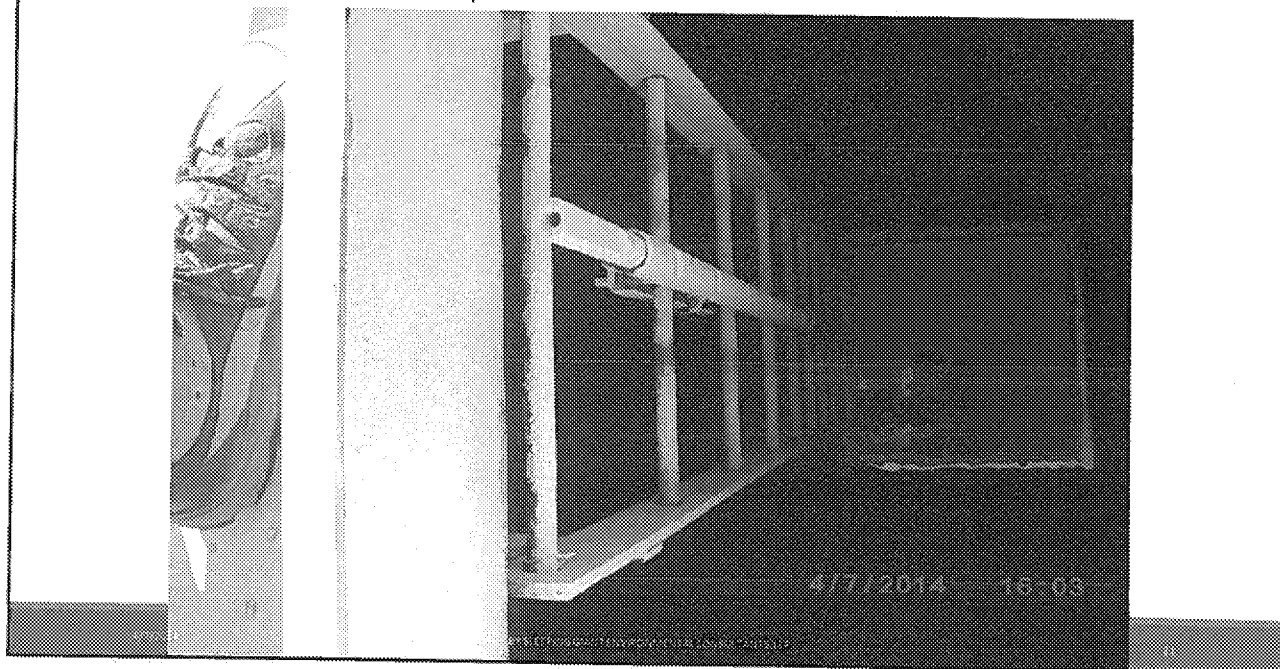
ST002/Newer East Storage Tank: The interior of the tank is starting to show some corrosion. It should be inspected by a tank company and, as needed, repaired/touched up.

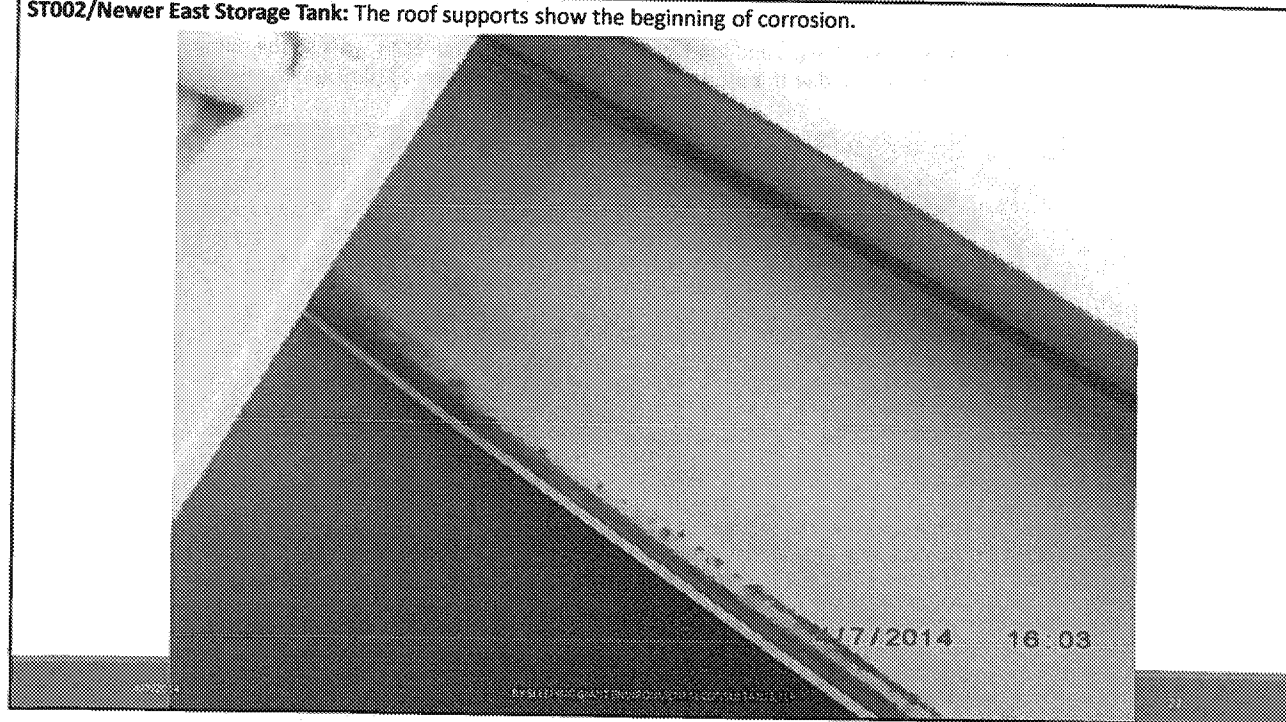
ST002/Newer East Storage Tank: The roof supports show the beginning of corrosion.

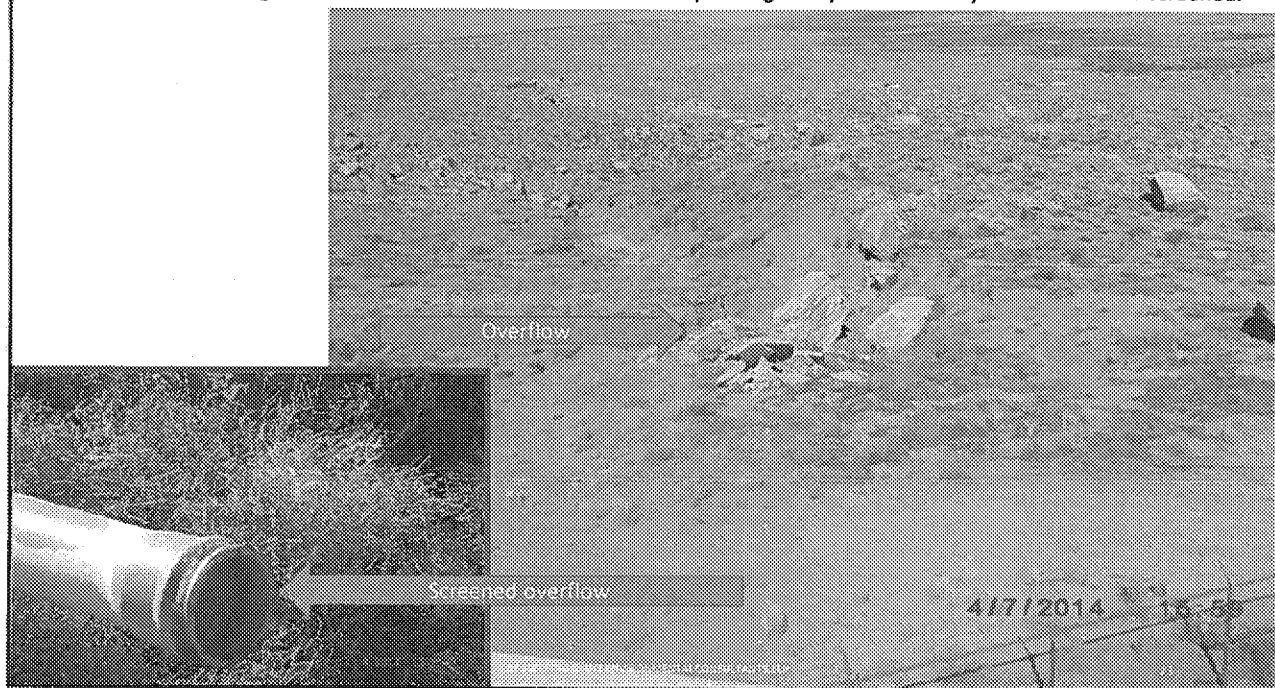
The overflow pipe terminates away from the storage tank with no splash pad (Photo 23). Insect screen covers the end of the overflow pipe. There is significant erosion at the site of the overflow. ST001 has a locked chain link security fence with one low spot under the fence (Photo 18). The outside of the storage tank is free of graffiti and appears to be in good condition.

ST002/Newer East Storage Tank: Note the erosion that results from operating the system manually. The overflow is screened.

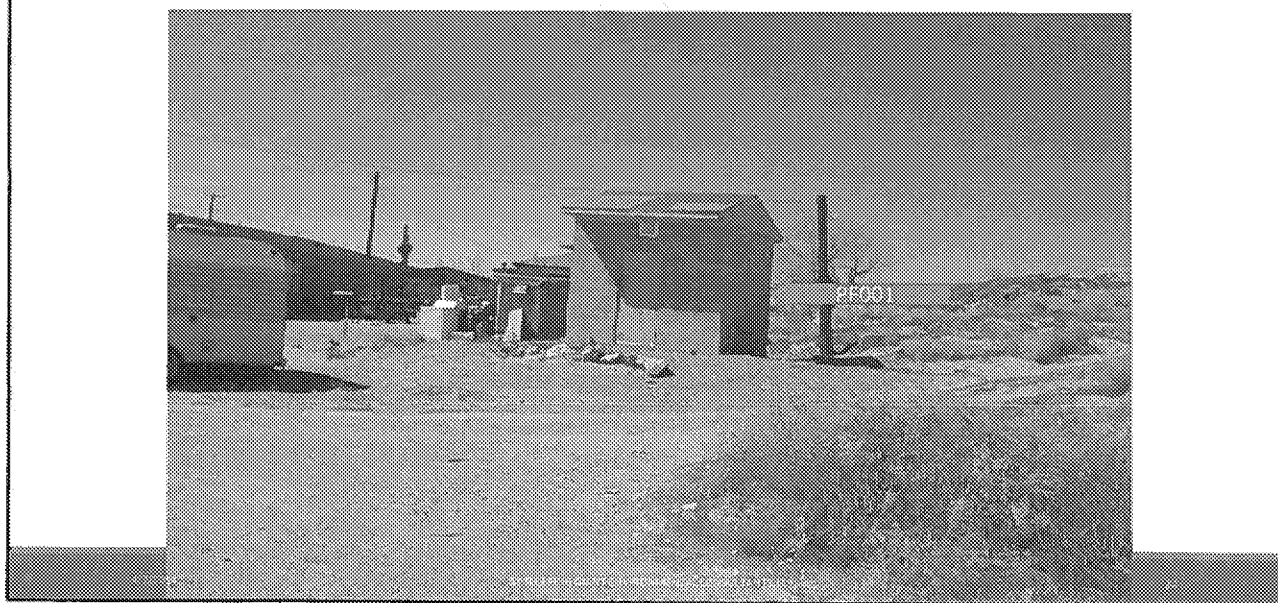
PF001/Pumping Facility to Upper Mesa: This facility pumps water from DS001, through a transmission main and to the upper Mesa where it is stored in ST003 (an 8,000-gallon ground level tank). The automation doesn't work so the pump is operated by a timer. It runs one hour at a time six times each day. If it produces excess water, it overflows ST003 and the water runs off the mesa.

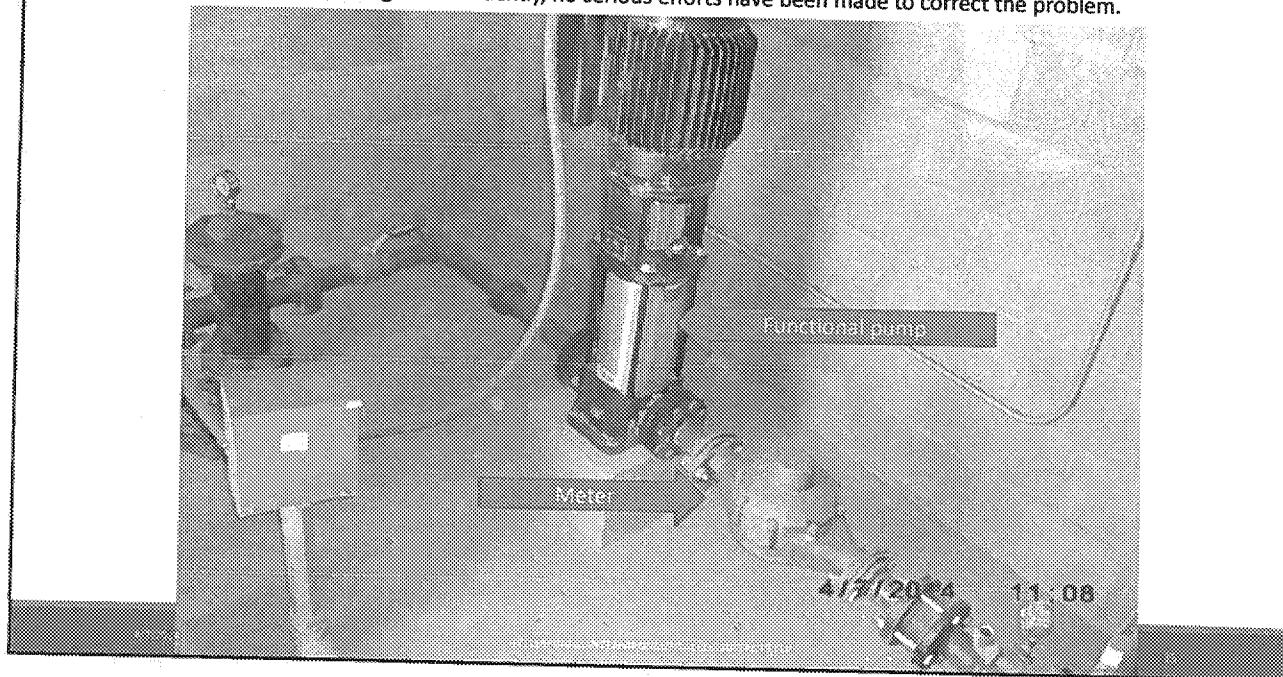
3. **Redundancy at booster pumping facilities* (PF001 – P2 – Health Risk Priority 1):** PF001 has only one pump that is operational. The other pump has apparently been out of service for roughly eight years. As noted above, this can cause loss of service and pressure and lead to public health risks.

PF001/Pumping Facility to Upper Mesa: The duplex pumping facility has had only one pump that works for years. The other is down, reportedly, because of a bad gasket. Evidently, no serious efforts have been made to correct the problem.

Recommendation: Make repairs and/or replacements as necessary to ensure the necessary redundancy is present.

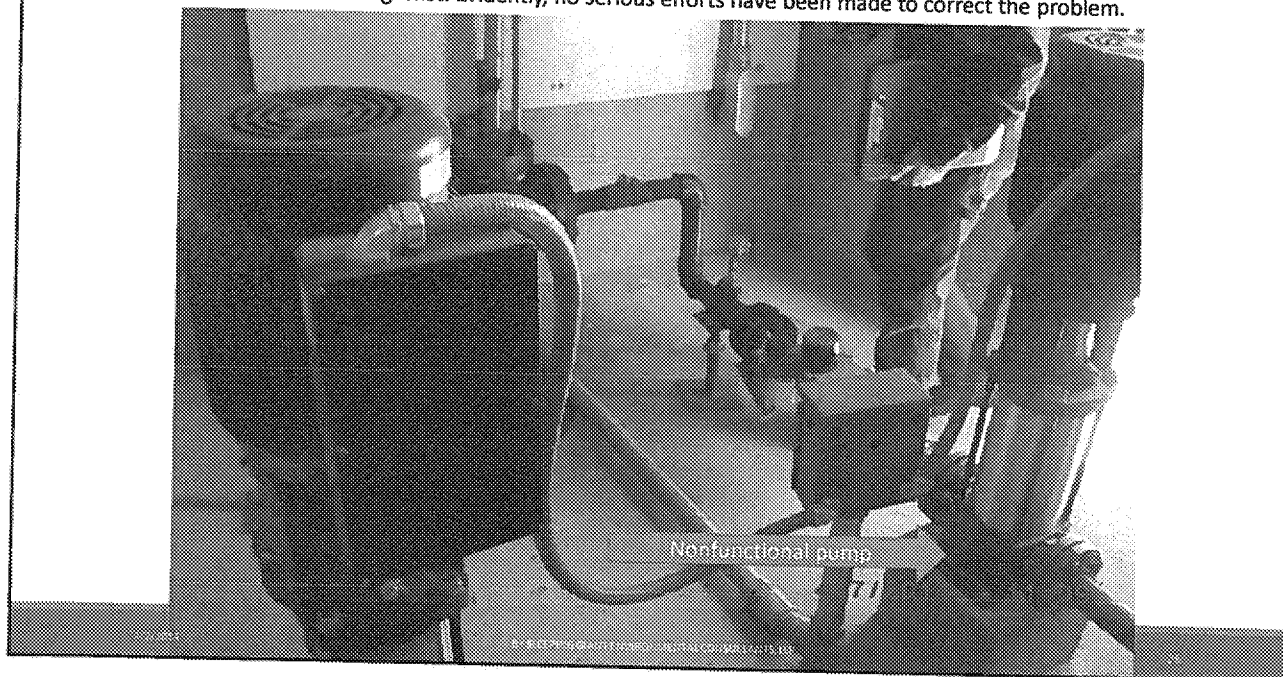
PF001/Pumping Facility to Upper Mesa: The duplex pumping facility has had only one working pump for years. The other is down, reportedly, because of a bad gasket. Evidently, no serious efforts have been made to correct the problem.
